HYDRAULIC TUBING UPGRADE FOR THE 380SF SINGLEFACER

original parts & service for
Langston

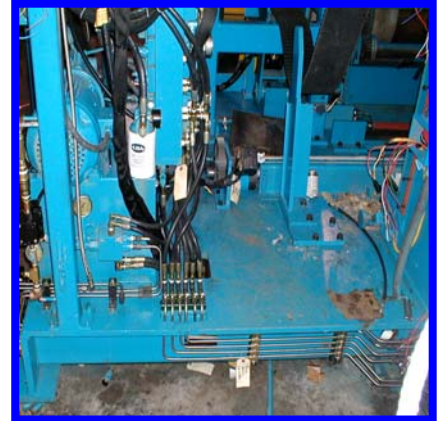
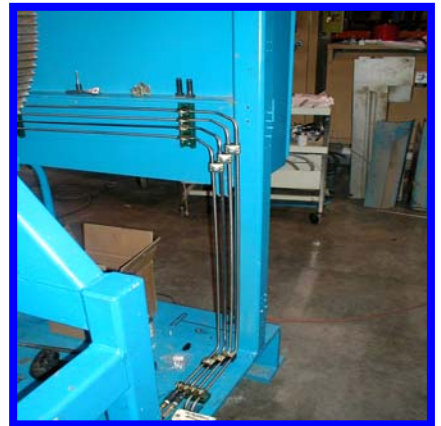
Views of tubing conversion

With this upgrade, all hidden hoses are replaced with stainless steel tubing, which is virtually maintenance free. All lines are on the exterior of the bedplate making them readily accessible. The only hoses used are short lengths from the end of the steel tubing to the device (i.e. the cylinder, valve, etc.). This also makes it easier to isolate individual devices for troubleshooting purposes.
