Register Upgrade

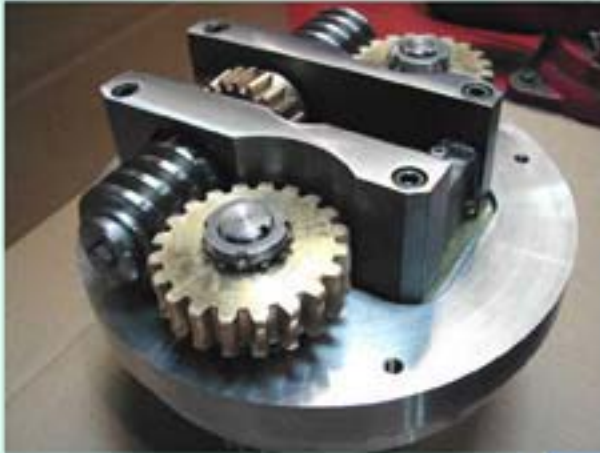
Our upgraded register is supplied fully assembled with a Ringfeder connection between the inner hub and the journal. In most cases the journal does not have to be removed.
