Mid-Atlantic Packaging Increases Speed, Print Quality and Productivity with SUN Automation Group® Retrofit

SunTrac Vacuum Transfer upgrade improves performance of 1986 Martin RapidSet

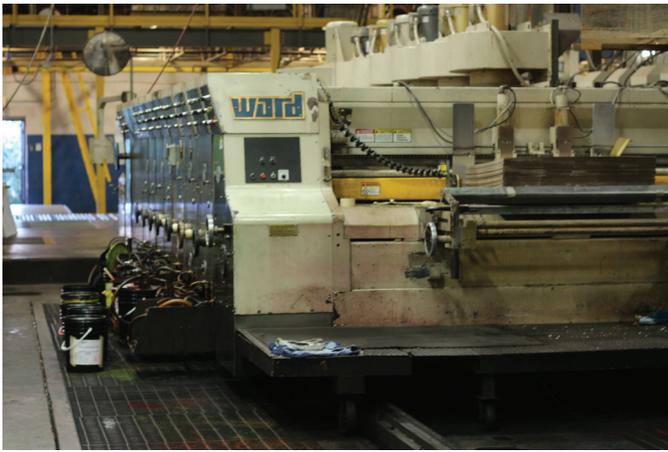
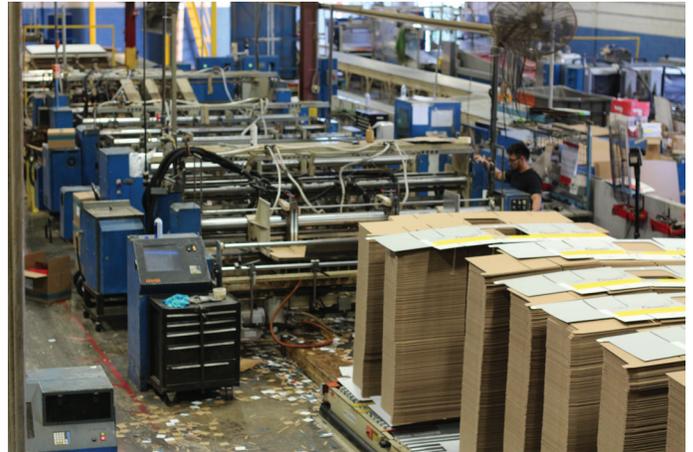
So when time came to look at the Martin, SUN knew immediately what needed to be done and suggested its SunTrac® Vacuum Transfer system. The simple retrofit is available for both top and bottom printing equipment and works by keeping boards in a firm position throughout the machine. By enabling optimum board path from print nip to print nip, SunTrac further eliminates jams and improves speeds and print quality. It also allows MAP to run small flute board effortlessly to meet growing market demand and removes many of the high maintenance items that also make up for long set-up times.

But before MAP could reap the benefits of this retrofit, it needed to be installed. Looking to minimize downtime, SUN worked with MAP to ensure the process wouldn't disturb operations and increase customer lead times. To accomplish this, the four-color machine was broken into sections, with a two-color section removed and placed in the back of the plant. After a one week tear down, where obsolete components are removed and new SUN technology is installed, the section was ready to be put back in. The following week it was installed along with the vacuum transfer and the next section was pulled out and improved as well.

In fact, speeds nearly doubled and quality improved immediately leading to more than a 25% increase in production on every run. Precise control of sheet travel from frame to frame also meant that lead and tail trip could be reduced or eliminated. But the savings did not end there. SunTrac installation enables the removal of the pull collars and shafting-- freeing up space and reducing future maintenance costs as most of the parts previously needing more maintenance have been permanently removed. In addition, workers have more room to work on the machine and simpler controls and electrical components to operate it. The additional space can also be used to create a dwell space between the last print unit and the die-cut unit to avoid print distortion caused by the die-cutting process. It can also be used to install dryers.
